Historic Barn & Farm Foundation of Pennsylvania (HBFF)
Barn Preservation Grant
Grant Year 2023 Application

Date of Application: December 1, 2022

Double Decker Barn

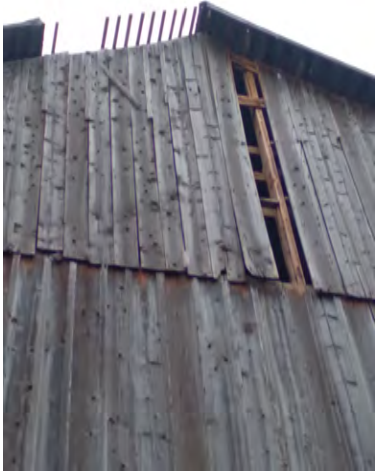
Longstanding water and wind damage caused by a neglected roof, failed guttering, and missing large doors has put the structure at risk. Especially, the roof's north (bank) side is weather-affected. The northwest corner of the roof is uncovered. Other sections are loosely nailed and rusted. Failed guttering, missing downspouts, and missing large doors compound the damage on the north side.
See photos in Appendix A.

North roof missing (western view) November 16, 2022

The north side roof will be entirely replaced using corrugated steel roofing with galvanized or dark color finish. Existing fascia (roof edge trim) will be matched to the width and depth of overhangs with material in a compatible color. An experienced barn builder will do the roof work. ██████████ will replace the guttering, downspouting, He will replace the missing large doors on the north side with new wood construction. If smaller doors are replaced, new wood construction and existing hardware such as wrought-iron strap hinges will be used if possible.

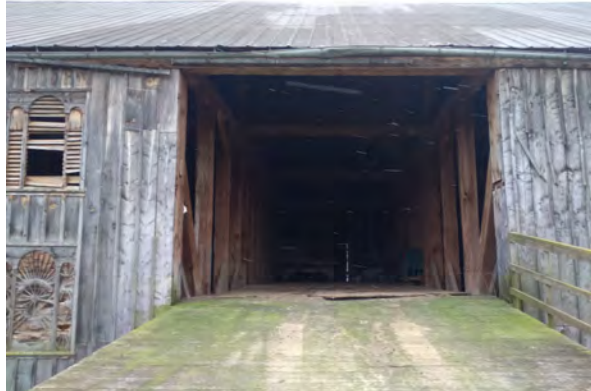
Missing door, damaged gutter, weak roofing November 16, 2022

Repairing the weakened north roof, replacing failed guttering, and replacing missing large doors will extend the lifetime of the timber frame structure. For farming purposes, the project will improve dry storage of grain and equipment.

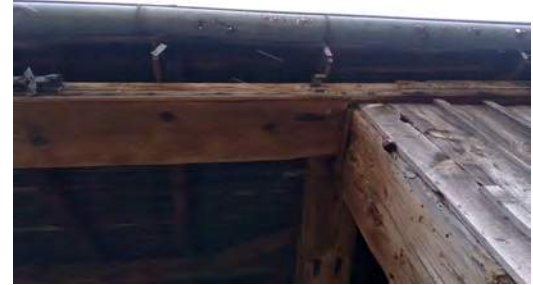
Damaged gutter November 16, 2022

██████████ will repair the guttering, downspouts, and doors in winter 2022 or spring 2023, depending on the availability of materials. The roof and fascia repair will be done in spring 2023.

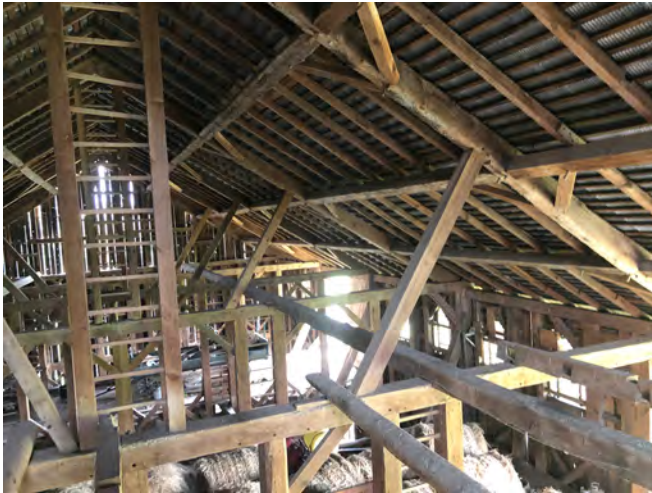
Exposed interior September 21, 2021

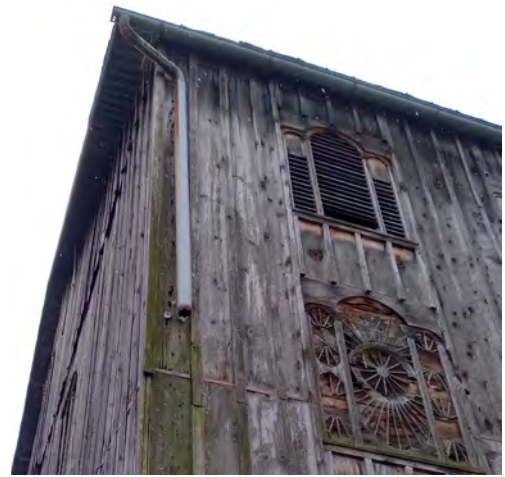
No downspout November 16, 2022

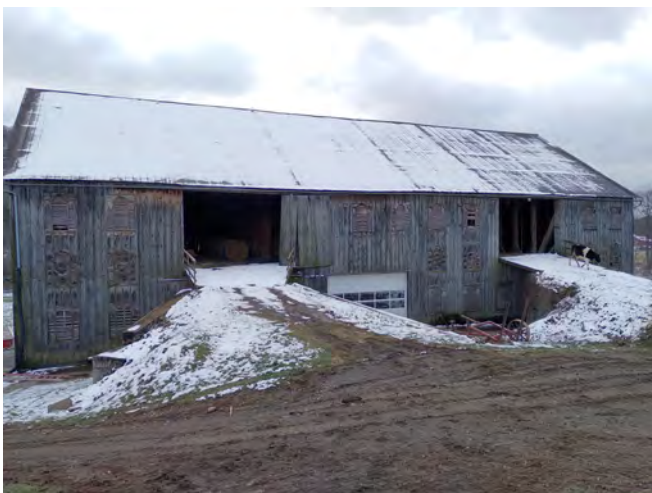
Missing doors and downspout November 17, 2022

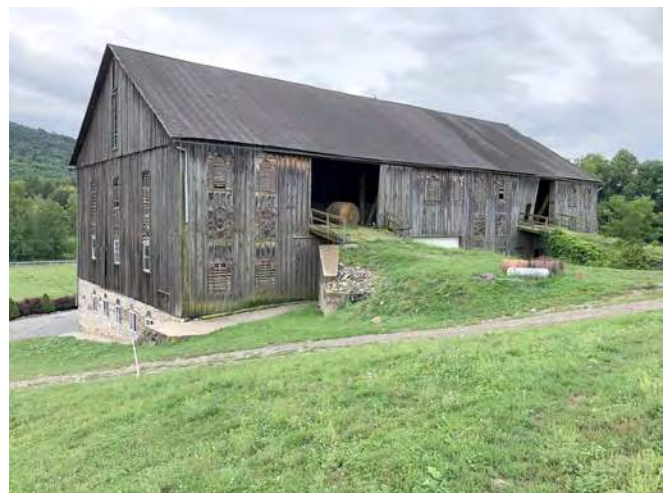
Missing doors, downspout September 21, 2021
